November 2006

# Monumental Issues

## Trinity Box Tomb Transformed

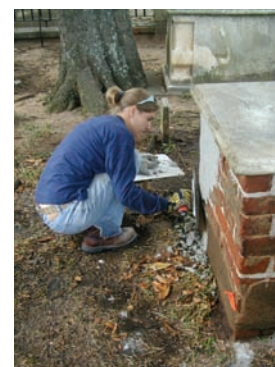
**Nicole Southerland applying Jahn stucco to the Mary Hampton box tomb.**

Unfortunately, the Mary Hampton tomb had been ignored for years and much of

the stucco was in very poor condition or had already failed. The underlying brick, while sound, suffered extensive damage to the soft lime mortar. And the ledger itself was discolored by biologicals and atmospheric pollutants.

The first step was to gently remove all of the loose and failing stucco. We found most of this to be composed of an inappropriate hard Portland cement. Areas where the original stucco could be found suggested that it was much softer.

Afterwards it was necessary to repoint the brick using a lime putty mortar. Some brick that was badly spalling had to be

removed and replaced with matching brick in better condition. This work had to cure for a month before new stucco could be applied.

- Jahn M60 Stucco was the product chosen for the treatment of the Mary Hampton tomb.
- Prior to any stucco application it is critical that the brick and mortar joints be carefully cleaned and repaired.
- For most box tombs the mortar should be high lime, often a lime putty.

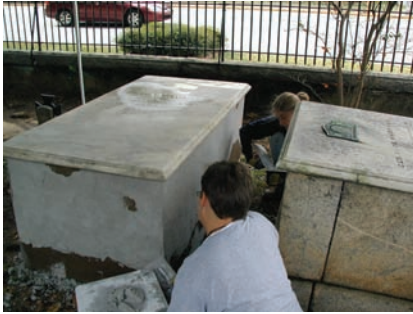
Julie Poppell and Nicole Southerland with the Mary Hampton almost completed.

The stucco chosen for this project was Jahn M60. Available from Cathedral Stone, this is a single component, cementitious mortar that is compatible with the substrate and allows ready movement of water vapor.

No color matching was chosen since the stucco was going to be colored with Silin® Lasur mineral stain to replicate white-wash, but provide greater dura-

bility and less maintenance (this final application has yet to be applied since we are waiting for warmer weather).

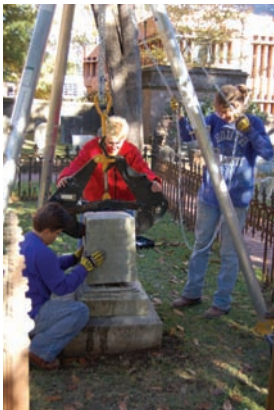
Although an aluminum tripod such as this can make moving heavy monuments easier, it also requires additional safety practices.

A case in point is the use of aluminum tripods and gantries for the movement of heavy

stones. Both are used at Chicora, depending on the space involved and the weight (our aluminum tripod is used for stones up to 1 ton, while our gantry is rated up to 2 tons).

Steel toed boots are a must. But so, too, is an understanding of how to inspect the rigging and

hoist for damage; understanding load limits, and being able to prepare the load for lifting.
